TDD # F1-8005-01F

December 5, 1980

SITE INSPECTION REPORT  
of  
OLIN CHEMICALS GROUP PLANT

Eames Street  
Wilmington, Massachusetts

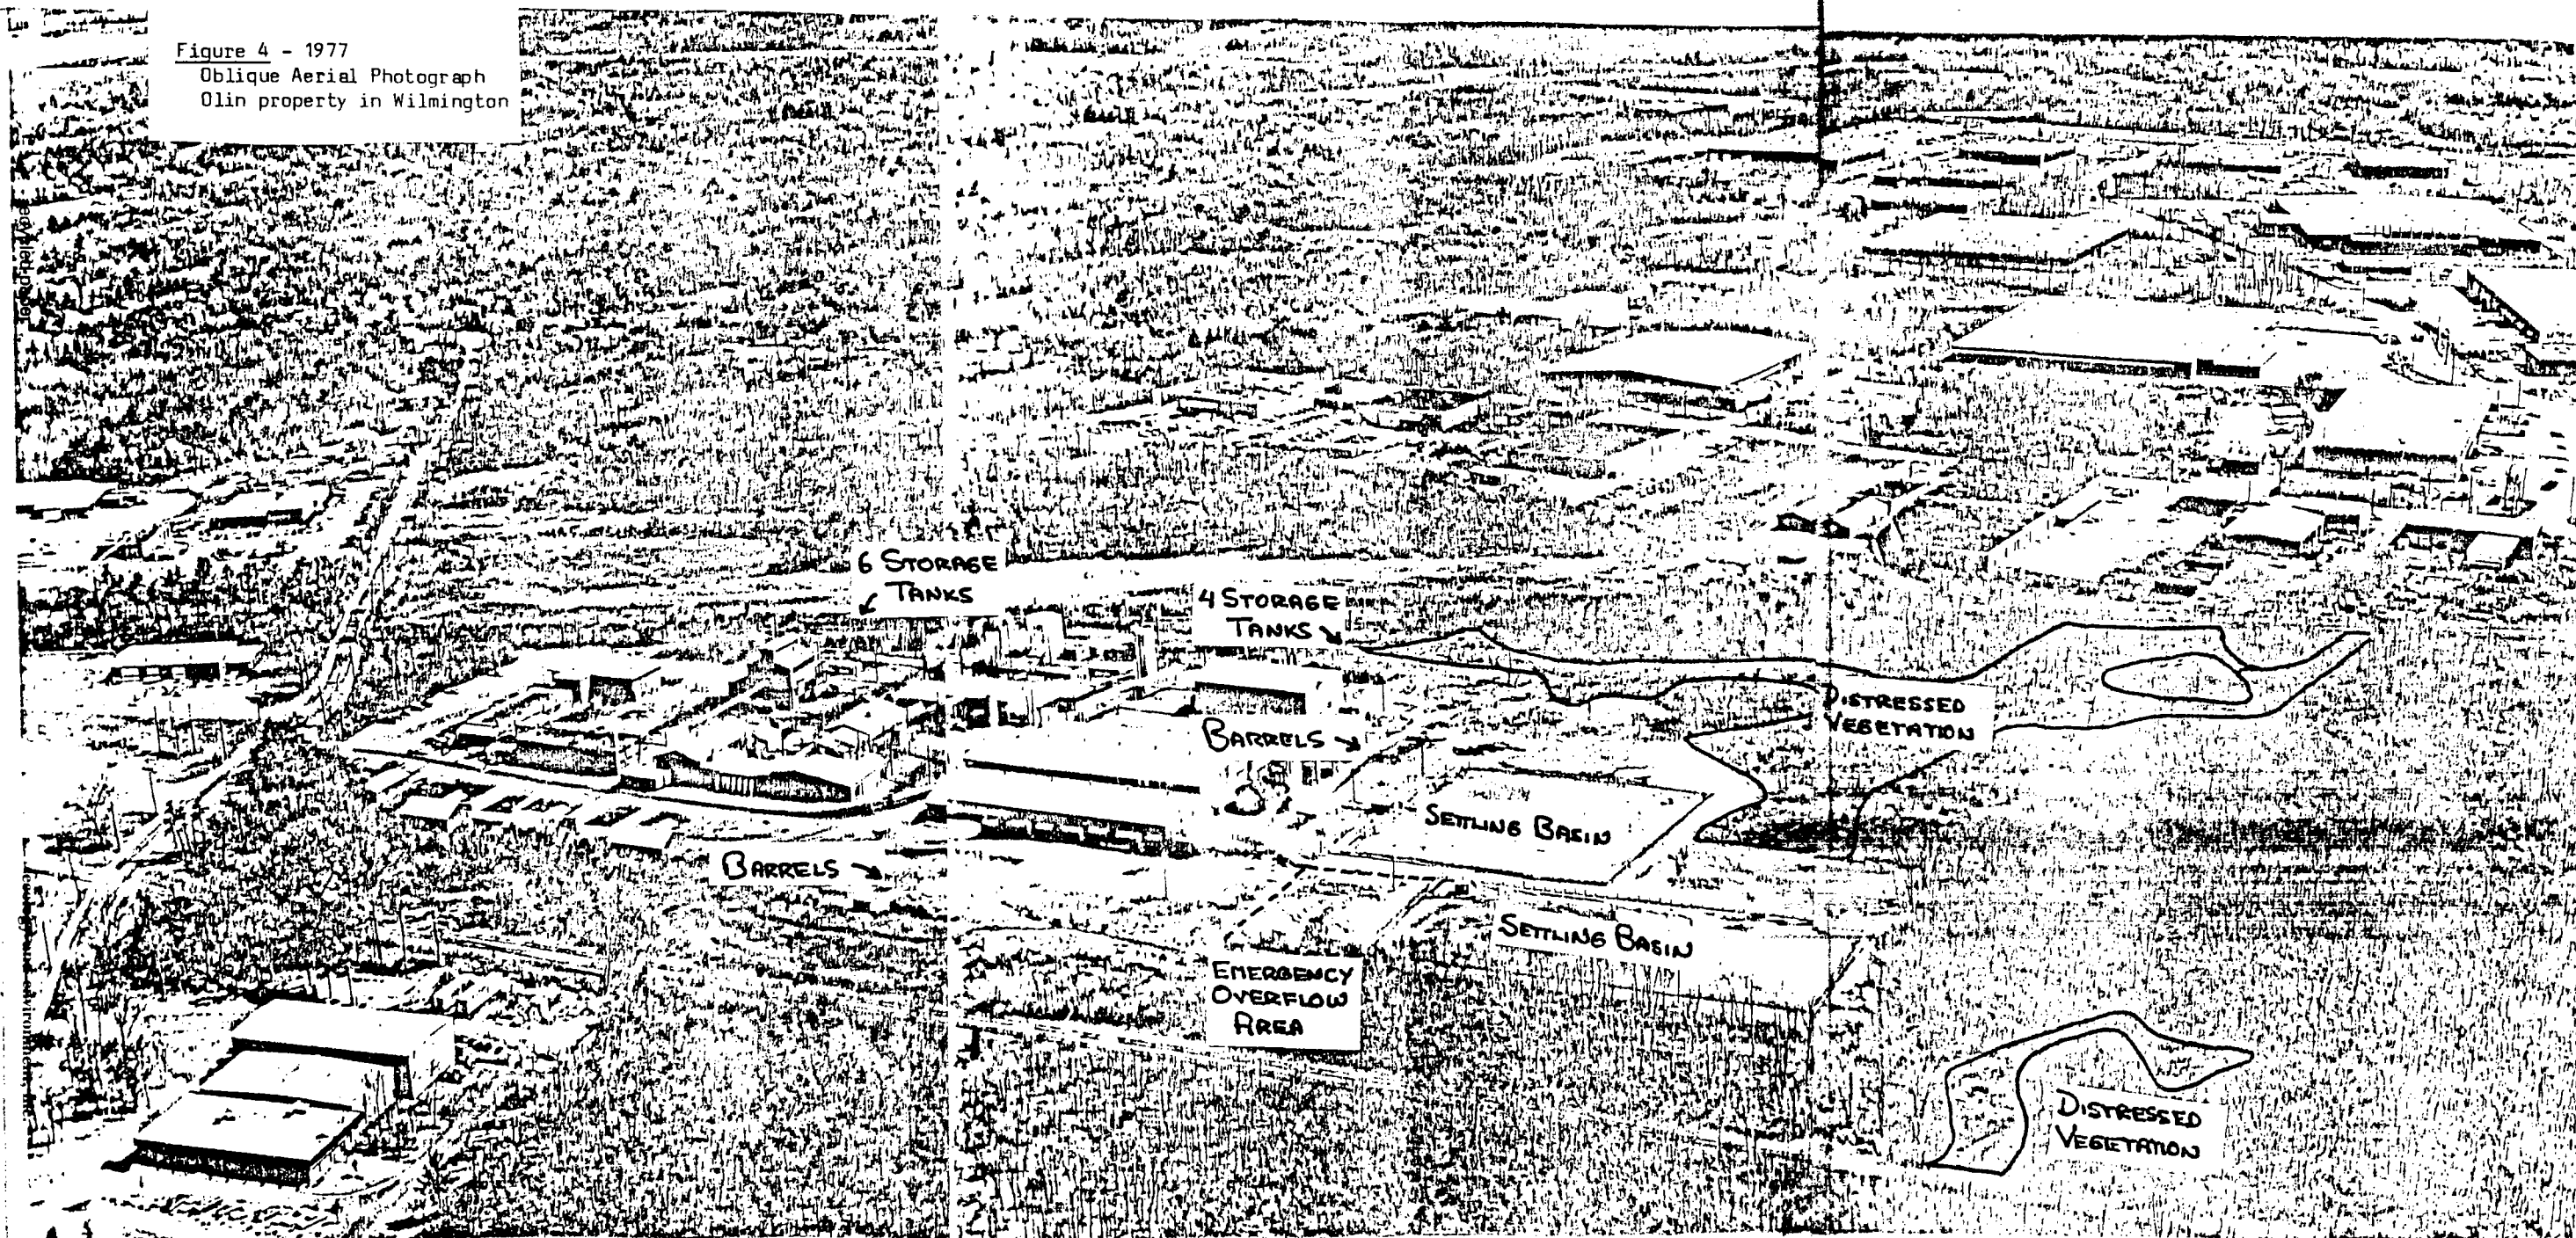
Figure 4 - 1977  
Oblique Aerial Photograph  
Olin property in Wilmington

A 1977 aerial photograph shows two areas where drums were stored on-site (See Figure 4). Leaks in these drums may have resulted in ground water contamination. The 1971 photo (Figure 3) also reveals a spill generating from the group of six large storage tanks on the east side of the property. Since 1973, "black ooze" has been noted seeping into the drainage ditch paralleling the railroad tracks east of the site (Figure 9). A sample was taken by the E & E, FIT team on October 2, 1980, (See memo to John Hackler from David Cook dated October 6, 1980), and the analysis should be available by the end of October.
